PERSONAL PROTECTIVE EQUIPMENT IN RESIDENTIAL CONSTRUCTION

KEYWORDS: Work safety. Personal Protective Equipment. Construction Industry.

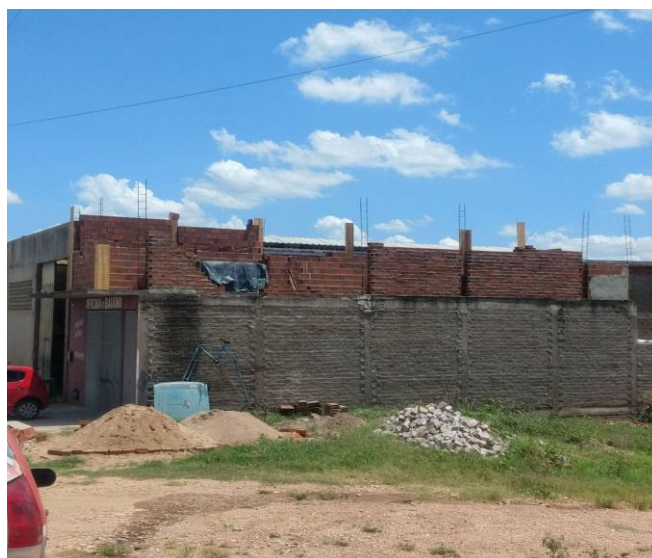
Figure 1: Site 1.

The construction sites referred to as " Site 1" is located along the PB 400 highway, at the outskirts of São José de Piranhas city, in the state of Paraíba. This development is intended for residential purposes and occupies the first floor of a building that also features a mechanical workshop. As depicted in Figure 1, the construction of the project was in an initial phase, characterized by the elevation of building masonry. The residence in question has an approximate area of 115.2 square meters and was being constructed by a team of three workers, consisting of a mason, a laborer, and an assistant laborer.

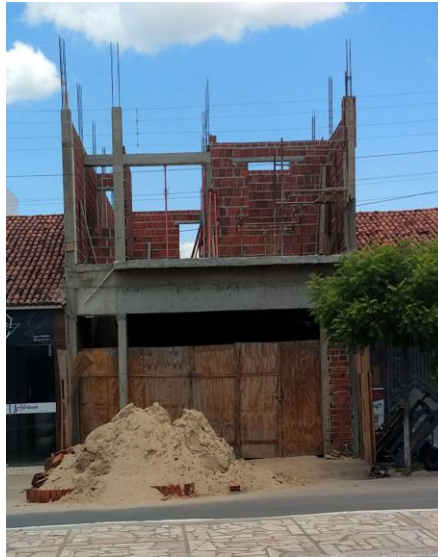
Figure 2: Site 2.

Site 2, illustrated in Figure 2, is situated on the first floor of a building and has a total area of 136.5 square meters, with dimensions of 6.5 meters in width by 21 meters in length. Located on Centenary Avenue, this project was in a more advanced construction stage, with the masonry of the building nearly completed. The construction was being carried out by a team consisting of two masons, two laborers, and one ironworker.

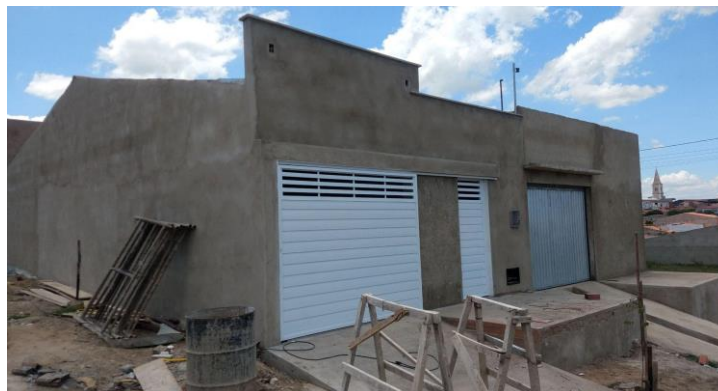
Figure 3: Site 3.

Site 3 pertains to a single-story house construction with a total area of 84 square meters, located in the Zuza Holanda neighborhood. The construction was in the finishing phase, as depicted in Figure 3, and was under the responsibility of a team comprising four workers, including two masons and two laborers.

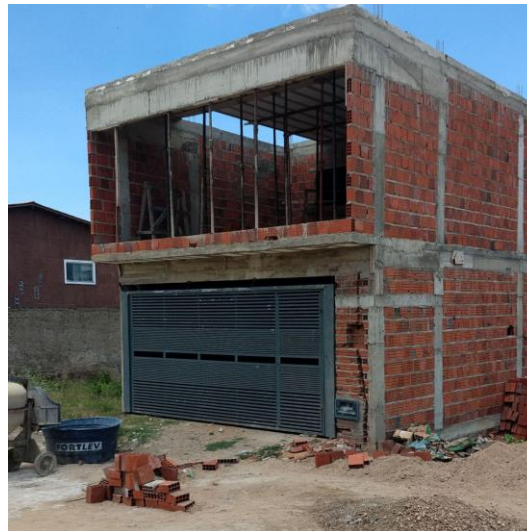
Figure 4: Site 4.

Site 4 encompasses an area of 240 square meters, with dimensions of 6 meters in width by 20 meters in length. It is intended for residential purposes and features both ground and first floors, as demonstrated in Figure 4. In this case, the construction phase was already well advanced, with the masonry and roofing practically completed, and the finishing stage was about to begin. The construction was being carried out in the Zuza Holanda neighborhood by a team of four workers, including two masons and two laborers.

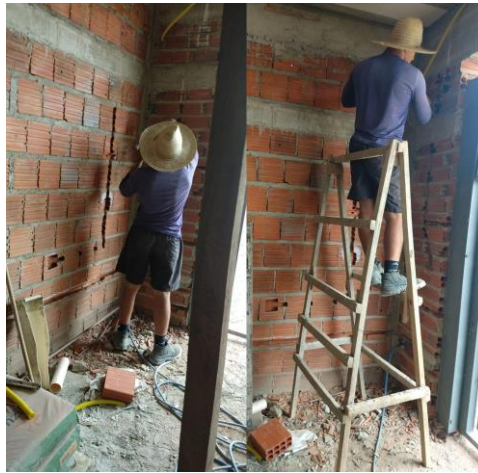
When comparing the four construction sites, it was observed that Site 4 exhibited the least compliance in the use of PPEs. In this location, only Laborer 1 was using boots and sleeves for the protection of arms and forearms. This was surprising as this construction site was more complex, featuring both ground and first floors. Therefore, it was expected to be more stringent in the use of PPEs to ensure the safety of workers. However, the construction site at Site 4 was the one that exhibited the most unsafe conditions and situations. A highlighted situation in Site 4 can be observed in Figure 5, where Laborer 1 was performing a masonry chase to introduce conduits into the electrical system. During this manual task, using a chisel and a mallet, the worker was not wearing gloves and goggles to protect their hands and eyes from small masonry fragments that were dislodging, thereby increasing the risk of physical injuries.

Figure 5: Laborer 1 from Site 4.

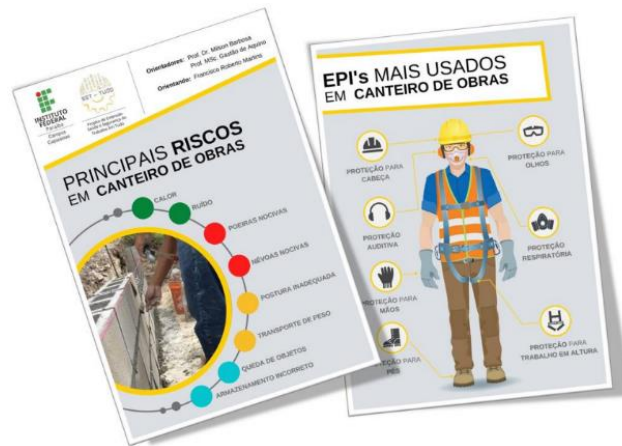
Figure 6: Pamphlets delivered at the visited construction sites.

Based on the observational analysis conducted at the four construction sites, it became evident that the workers lacked awareness of the importance of using Personal Protective Equipment (PPE), whether due to personal negligence or a lack of knowledge. Therefore, it is crucial for informal workers themselves to understand the importance of using Personal Protective Equipment (PPE) during the execution of their work activities. In this regard, one of the objectives of this study was to raise awareness among informal workers by conducting a follow-up visit to the construction sites, distributing pamphlets with information about best safety practices on construction sites. The pamphlets were designed in a didactic manner, considering that some informal workers have low levels of education. They highlighted the occupational risks to which they were exposed and illustrated the most common Personal Protective Equipment (PPE) used in construction (Figure 6). During the pamphlet distribution, a brief explanation was provided about the importance of workplace safety and the content of the pamphlet.
